# Solar Bankability

10/26/2016 Brussels (BE)

## An Assessment of Technical Risks in PV Investments

Ioannis Thomas Theologitis (SolarPower Europe)

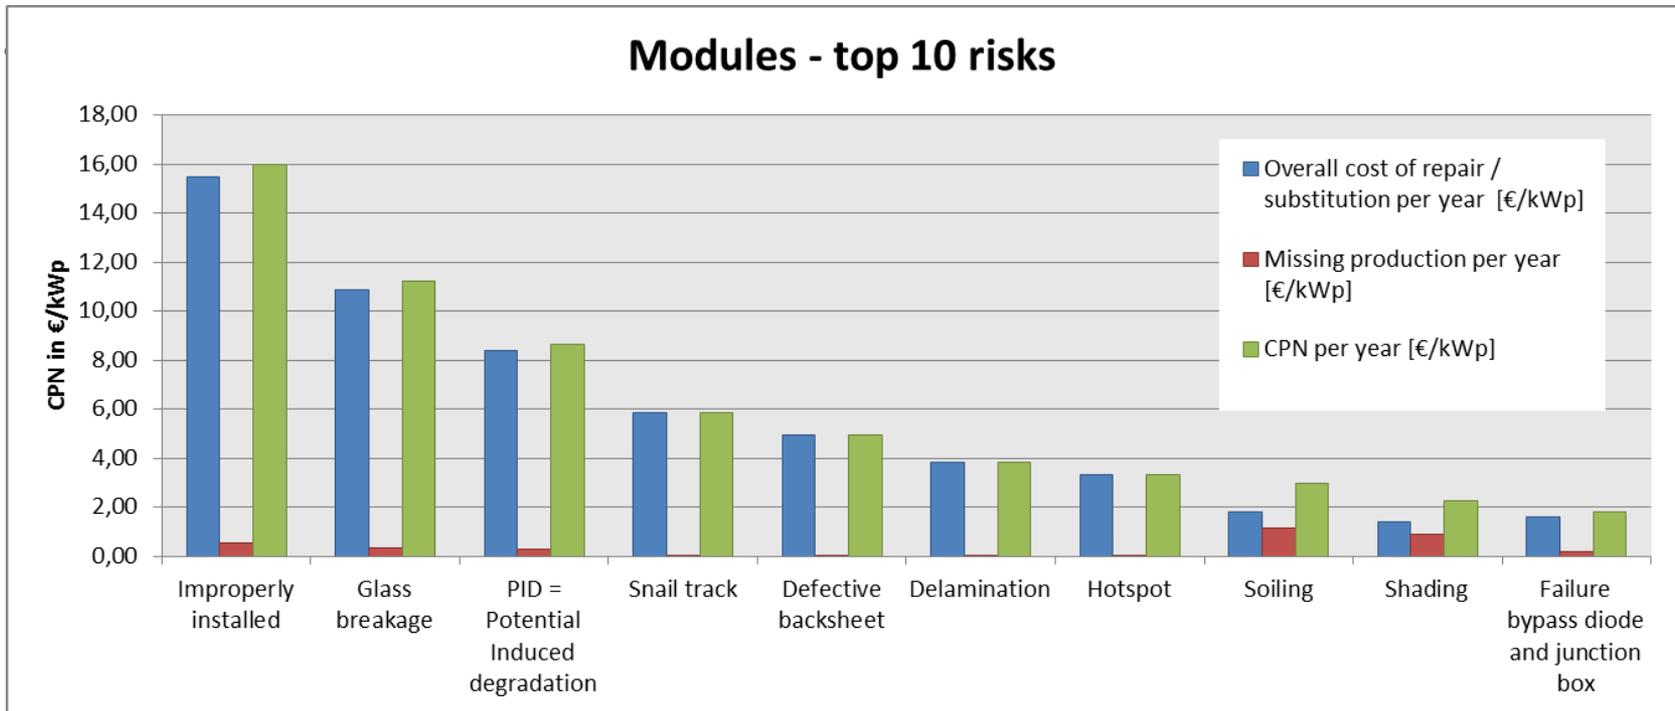
# Top 10 Module CPNs

- Highest risk consists of a group of installation failures (mishandling, connection failures, missing fixation, etc. )
- Variety of failures detected by different techniques (VI, IR, EL, IV-Curves)

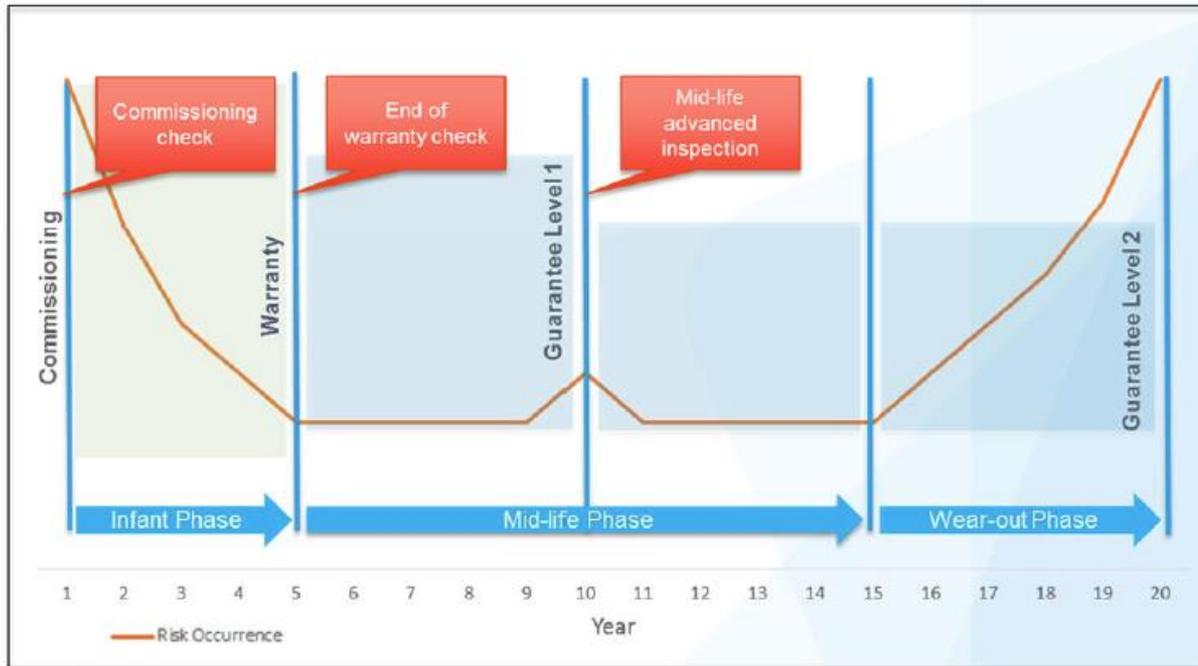
# Risk mitigation plan for the BMs

- A PV project will be exposed to several technical risks throughout its operational phase
- For each of the BM, a technical risk scenario has been created – combination of 4 technical risks from each project phase
- Repair and Maintenance cost assumptions have been made based on a list of >3500 insurance claims from all EU

*The impact of technical risks can differ to a large extent between **the base case** and **the worst case**. The base case of the cash flow model contains a provision for regular operations and maintenance costs. The worst case can exceed these provision and might require the injection of additional equity capital, in case the risk impact is neither covered by warranties, guarantees or insurances*

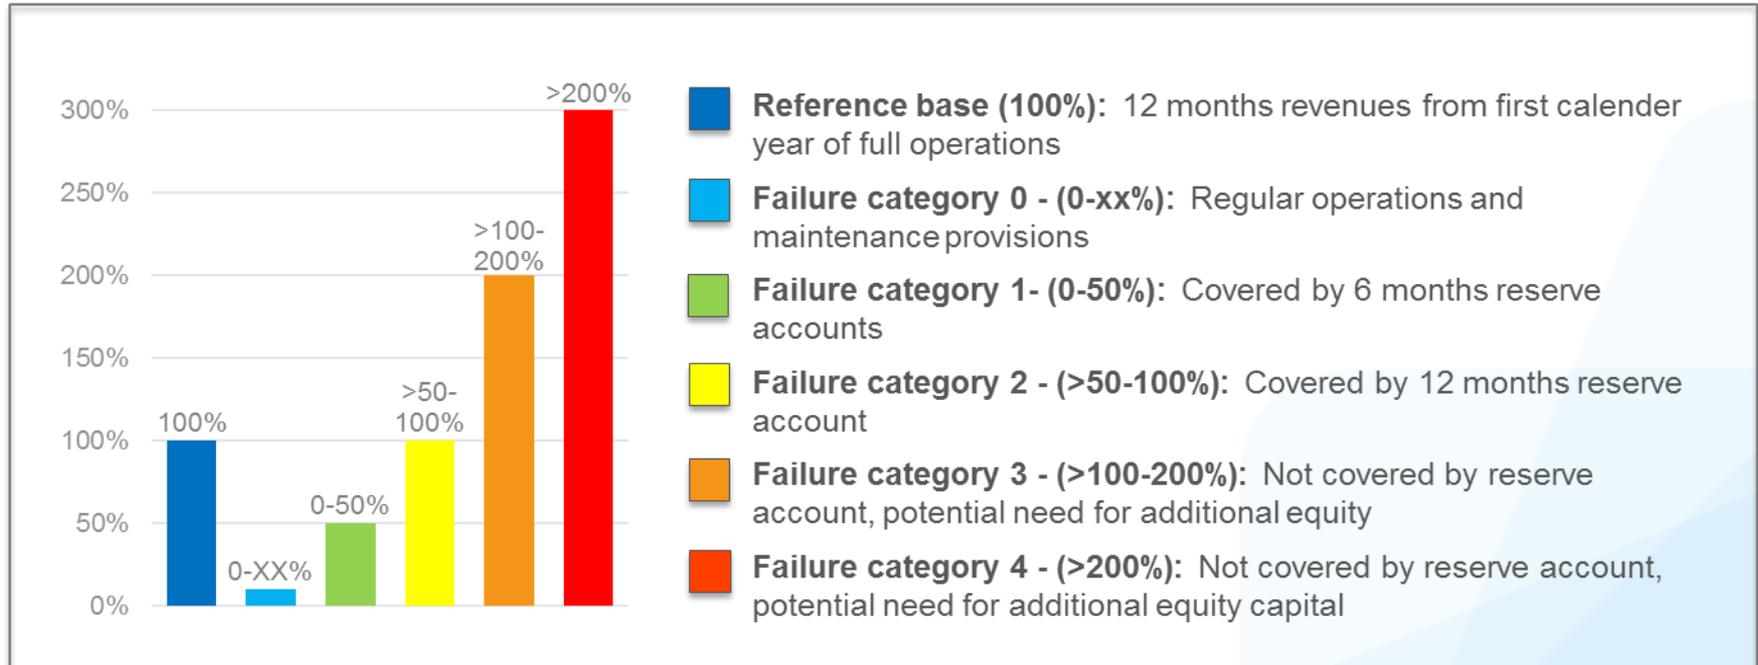
# Impact Categories of Technical Failures

A reserve account is often included in the cash flow model to buffer unanticipated business model risks. The size of the reserve account varies with the individual stability requirements of the investor or the financing bank. The size of the reserve account is measured as a fraction of the 12 months revenues in the first year of PV system operations - DSRA.

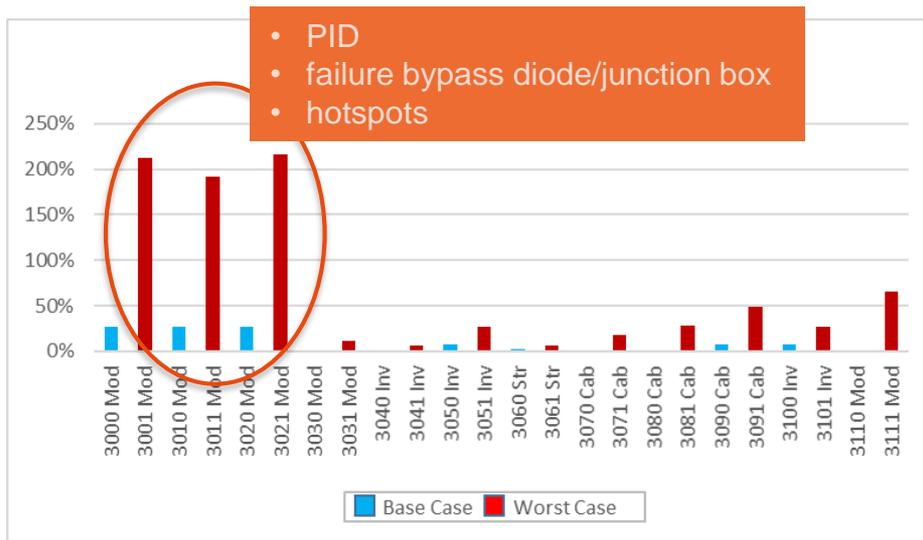
## Results by failure category

Business model 3 represents a utility scale PV system with a nominal capacity of 7.6 MWp located in central UK. The system consists of 7 central inverters, 190 strings per inverter and 22 crystalline silicon modules per string. The system was commissioned in January 2011. The owner is a financial investor interested in maximum system profitability
